# **Rail Safety Occurrence Report ARHS-NO-14-21**

**Level Crossing Collision**

**Grantley Avenue, Victor Harbor, South Australia**

**December 19<sup>th</sup>, 2021**

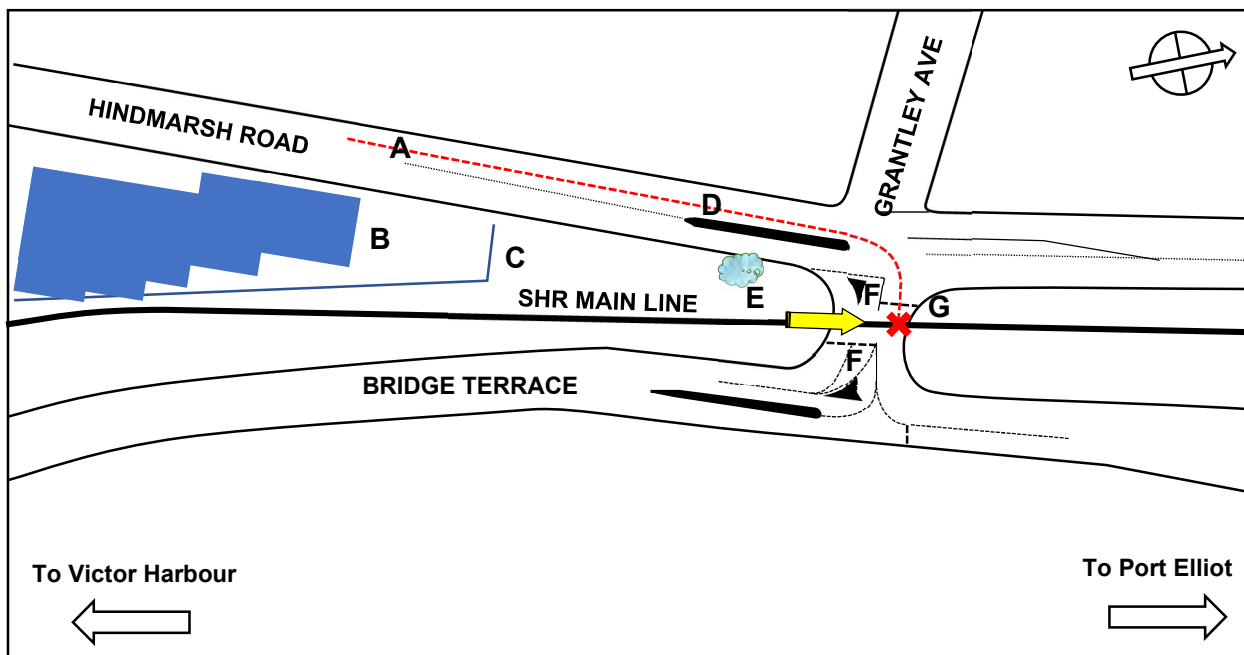
### 12.1 DIAGRAM 1 – SITE DRAWING

A – Path of road vehicle WWT-390 (shown as red line)
B – Buildings (117 metres from Hindmarsh Road and Grantley Avenue intersection)
C – Corrugated Iron fence (79 metres from Hindmarsh Road and Grantley Avenue intersection)
D – RX-4 sign assembly (32 metres from Hindmarsh Road and Grantley Avenue intersection)
E - Tree (29 metres from Hindmarsh Road and Grantley Avenue intersection)
F – Unidentified westbound road vehicles standing clear of level crossing
G – RX-1 sign assembly facing towards Hindmarsh Road.
The path of train 1552 is represented by the Yellow arrow.
The collision point is represented by the Red cross.

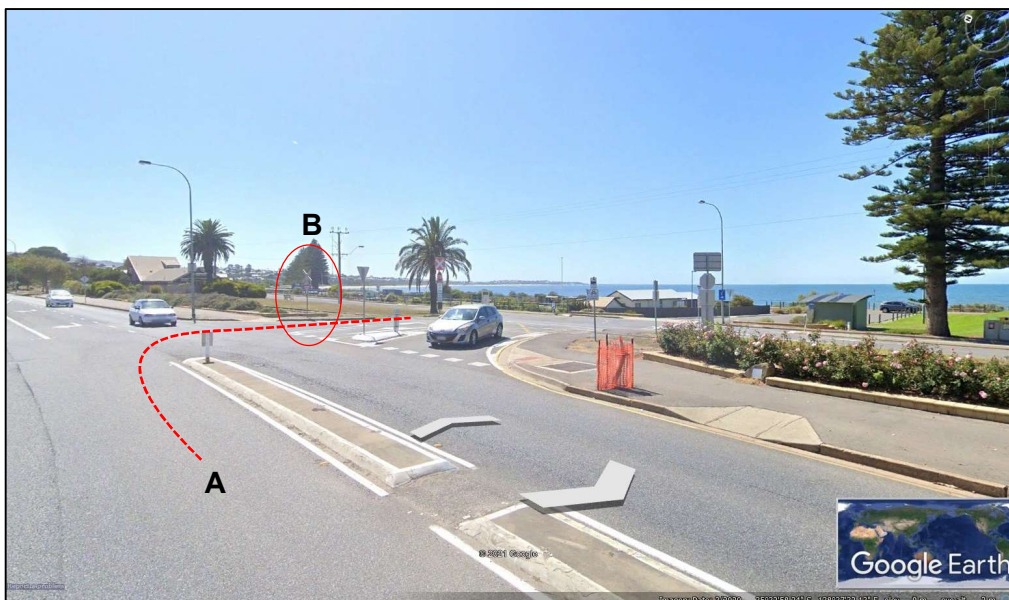
**12.2 PHOTOGRAPH 1 - HINDMARSH ROAD AND GRANTLEY AVENUE INTERSECTION**

*View of Hindmarsh Road and Grantley Avenue intersection and level crossing interface*

**A – Path taken by road vehicle WWT-390**

**B – RX-1 Level Crossing Sign Assembly**

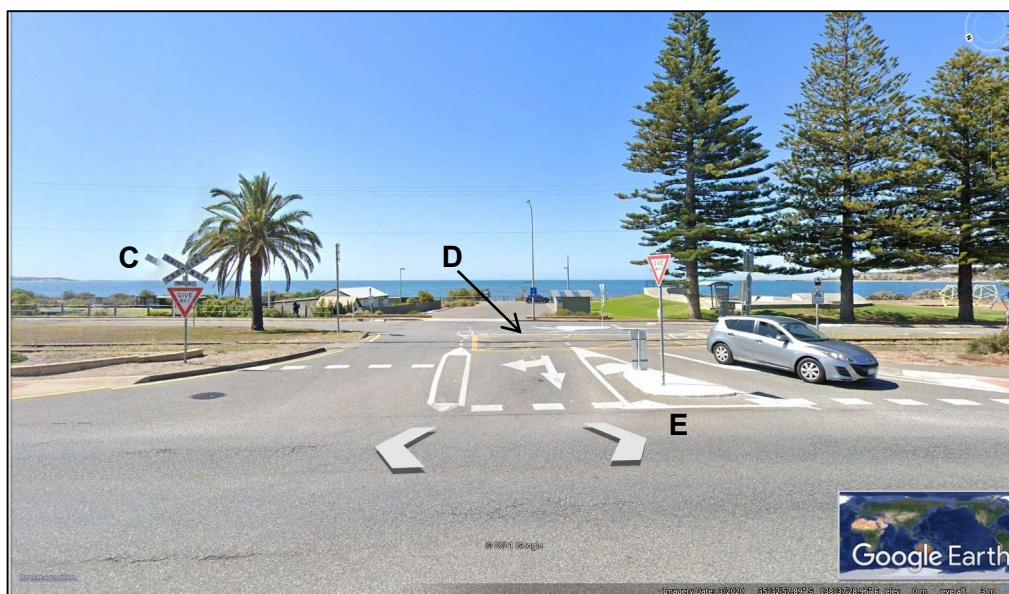
**12.3 PHOTOGRAPH 2 - GRANTLEY AVENUE LEVEL CROSSING**

*View of Grantley Avenue level crossing interface*

**C – RX-1 Level Crossing Sign Assembly**

**E – Give Way Sign**

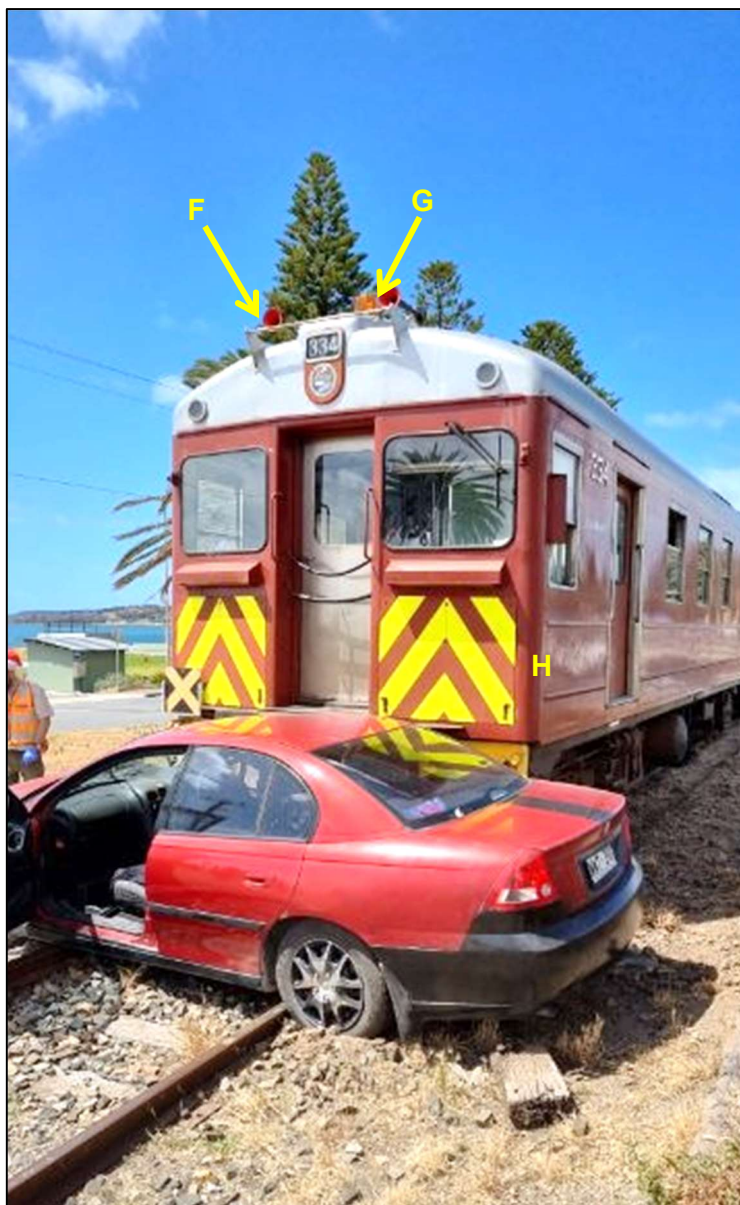
**12.4 PHOTOGRAPH 3 – DPM 334 AND ROAD VEHICLE**

The road vehicle disappeared from his sight, as the front of DPM 334 collided with it <sup>(6)</sup>.

The train slowed to a stand under full braking, and propelled the road vehicle approximately 29 metres toward Port Elliot <sup>(7)</sup>.

- (3) DPM 334 was provided with operating headlights, high-visibility rotating beacon lights, and was also provided with high-visibility panels on the front of the DPM.  
It appears as if this failed to make the approaching train conspicuous to the driver of the road vehicle.

*View of DPM 334 and WWT-390 following the collision*

**F – Air Horn (1 of 2 provided)**

**H – High-visibility “Day-Glow” Panel (1 of 2 provided)**

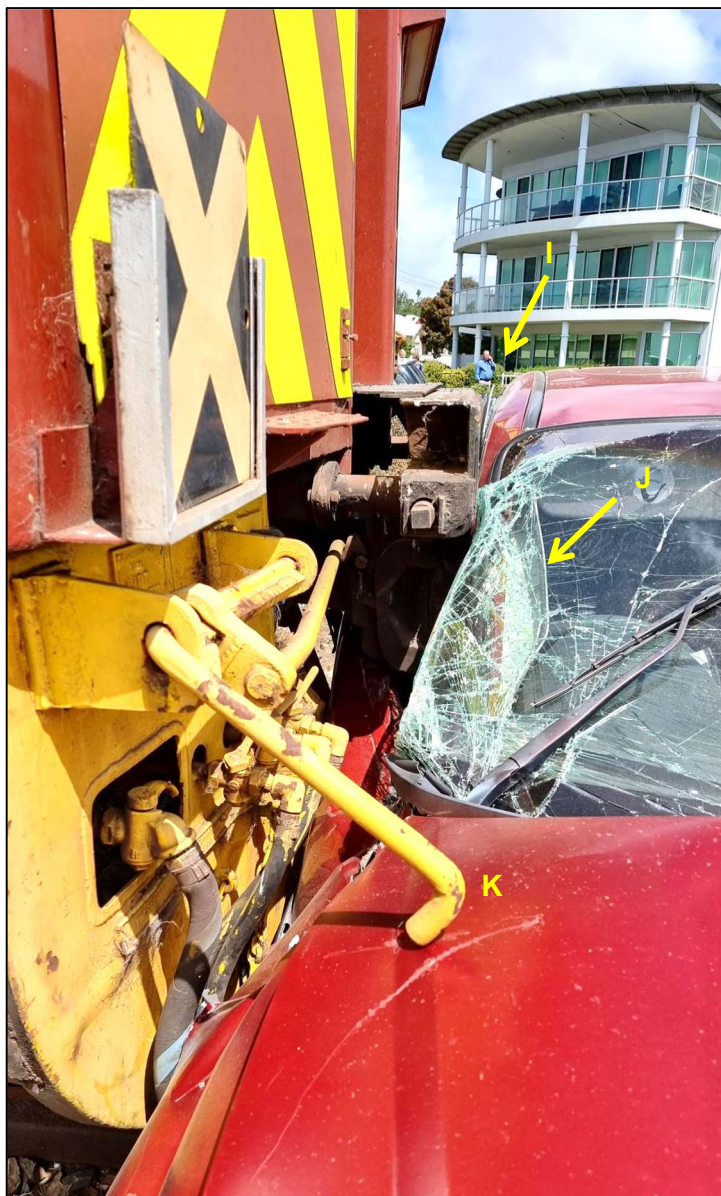
**12.5 PHOTOGRAPH 4 – IMPACT POINT BETWEEN DPM 334 AND WTT-390**

The rollingstock involved was found to have suffered only superficial damage, as the collision forces were borne primarily by the front coupler of DPM 334, and the buffer plate above the coupler.

*View of impact point between DPM 334 and WTT-390*

- I – DPM 334 Buffer Plate in contact with car roof**
- J – DPM 344 Coupler embedded in Driver's side window**
- K – DPM 344 Coupler Lift-Lever**

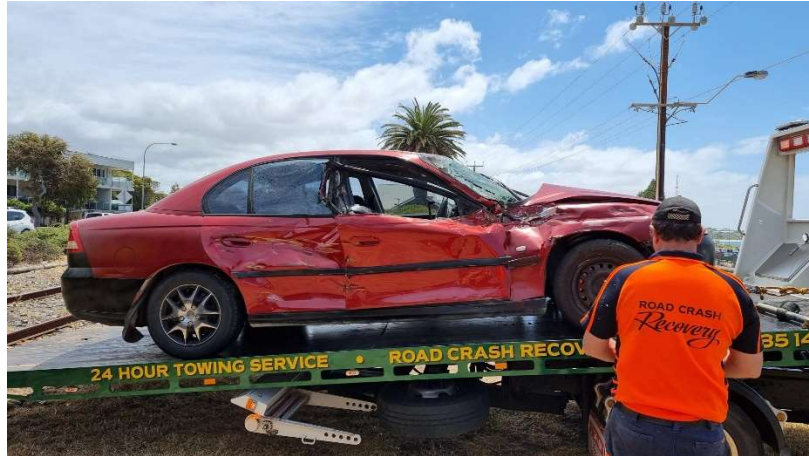
**12.7 PHOTOGRAPH 5 – DAMAGE TO ROAD VEHICLE WTT-390**

- (2) The road vehicle was extensively damaged as a result of the collision.  
DPM 334 suffered only superficial damage, and did not require any repairs prior to it being transported from the incident site.  
No damage was inflicted to the track as a result of the incident.

*View of damage to road vehicle WWT-390*

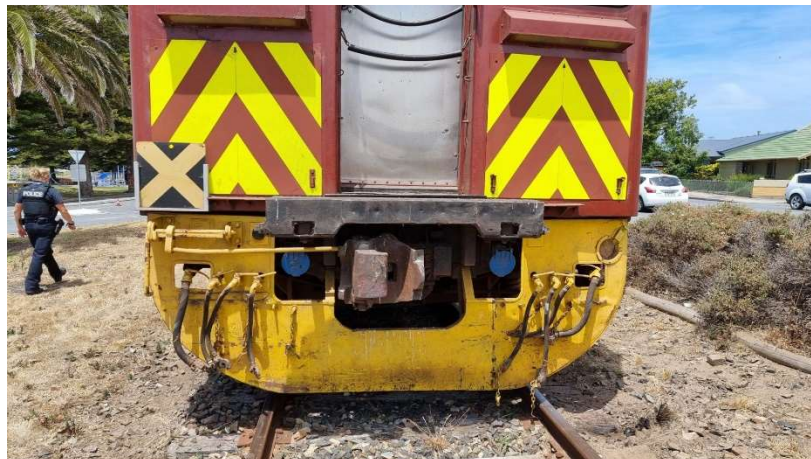
**12.8 PHOTOGRAPH 6 – DAMAGE TO DPM 334**

*View of damage to DPM 334*

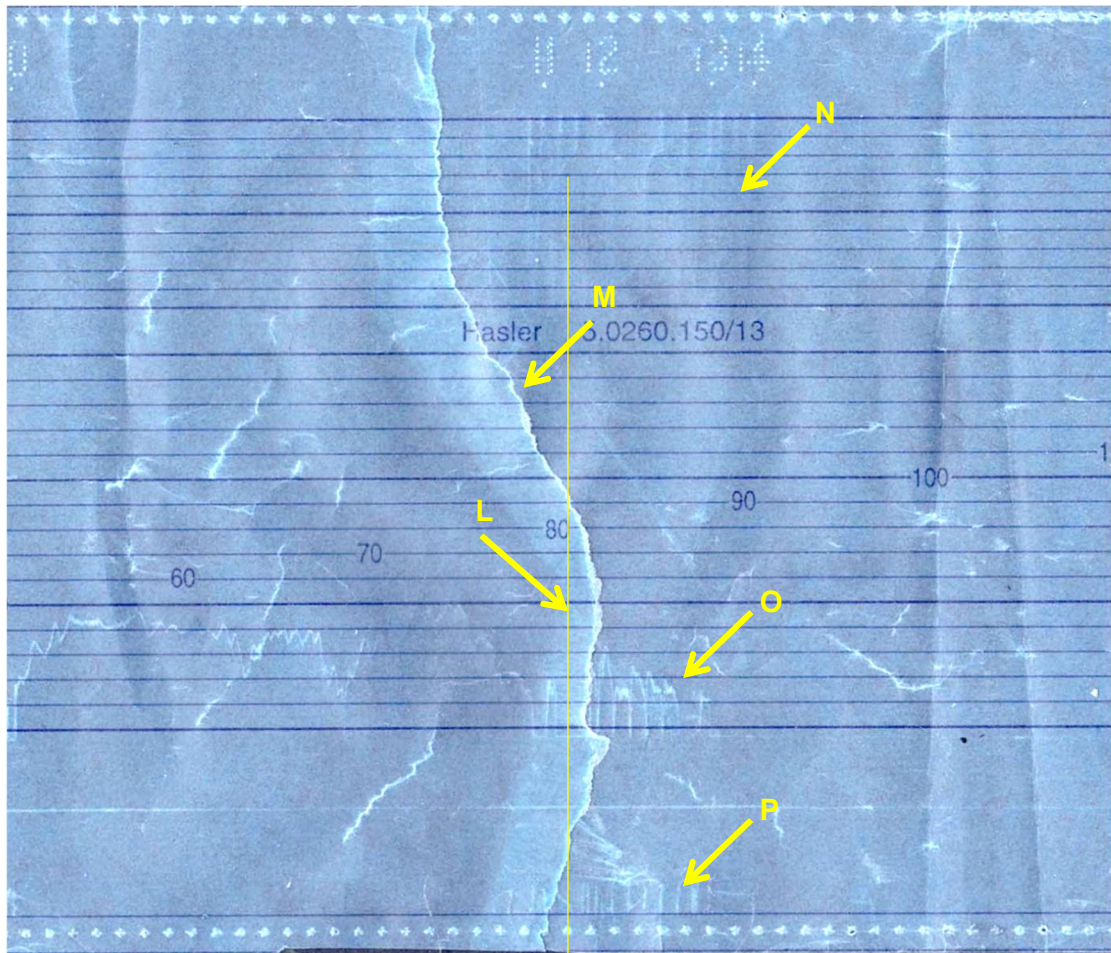
**12.9 DIAGRAM 2 – EVENT RECORDER CHART FROM DPM 412**

During the removal of the Hasler event recorder paper chart, it was damaged, and was torn at the point at which the incident data was recorded.

This may be as a result of wear, incorrect adjustment, or the incorrect installation of the speed recorder chart.

The event recorder chart was damaged, and was torn at the point at which the incident data was recorded.

Additional unrelated marks on the recorder chart were caused during its retrieval.

*Overall View of Event Recorder Chart - Damage to chart is evident*

- L – Incident datum line (Offset slightly to right)**
- M – (repaired) torn recorder chart**
- N – Indistinct time record lines**
- O – Speed lines**
- P – Brake Cylinder lines**

- (4) Replace the Hasler RT9 event recorder in DPM 412.
