# Level 3 Incident Investigation Report

## *Collision*

### *Alexandrina Road Goolwa*

### *RLX0144 'S Bend' Level Crossing*

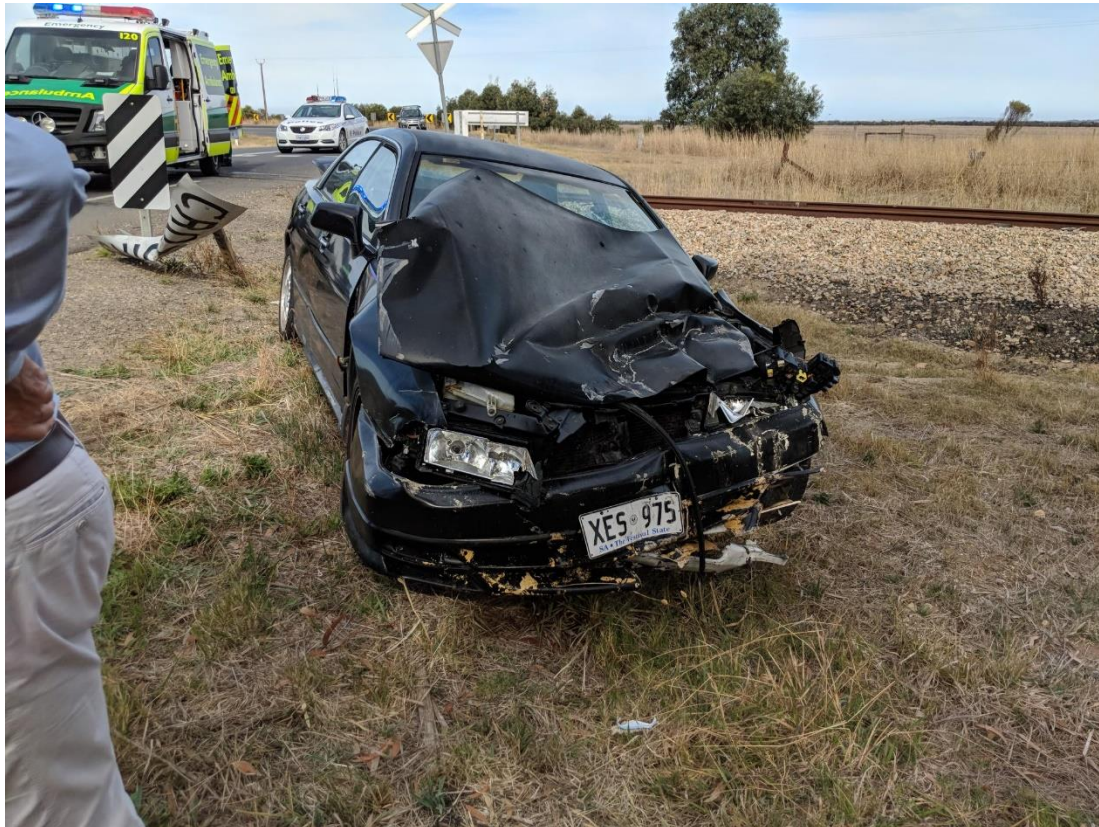
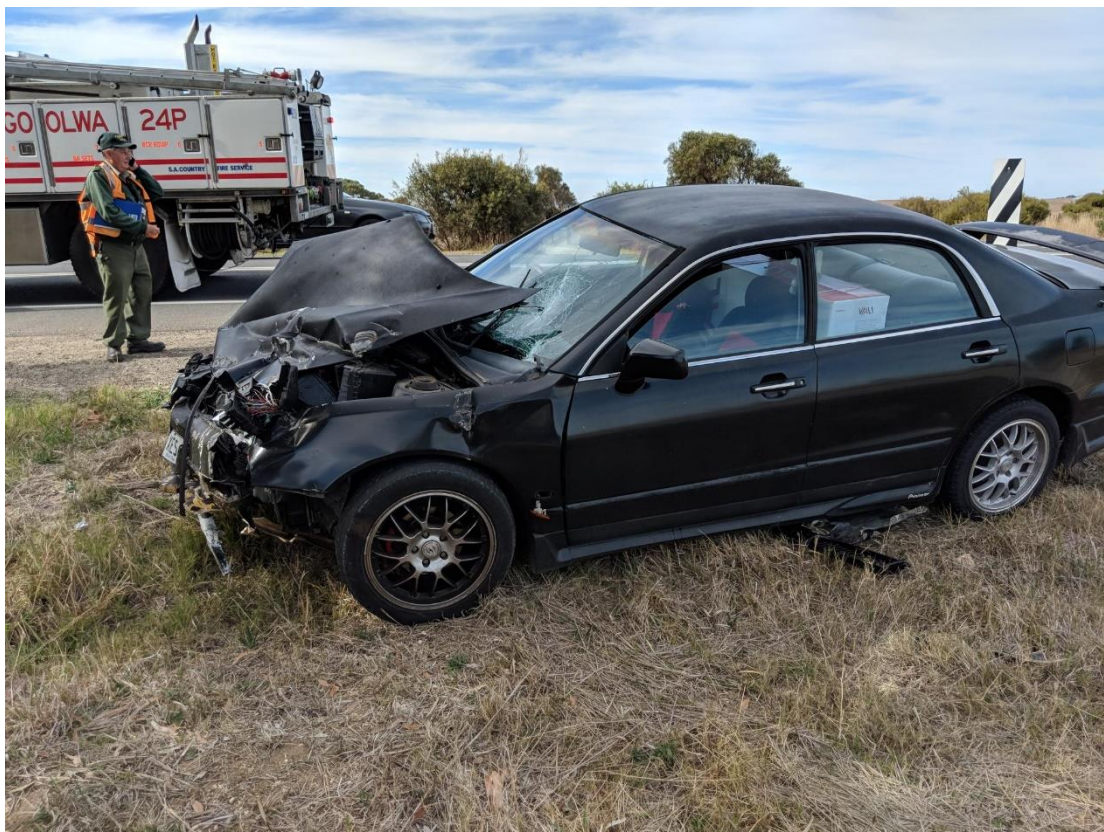
- The railcar had sustained significant damage to its cow catcher and one of the main supporting rods had been snapped from its anchor point.
- One of the 6 driveline V belts had been cut and one of the other belts although sustaining some damage was still functional.
- The rail vehicle was in no condition to continue the journey to Mount Barker but after appraisal was cleared to reverse back to Goolwa Depot.

- Impact occurred to front left hand side causing extensive damage to the front of the vehicle.

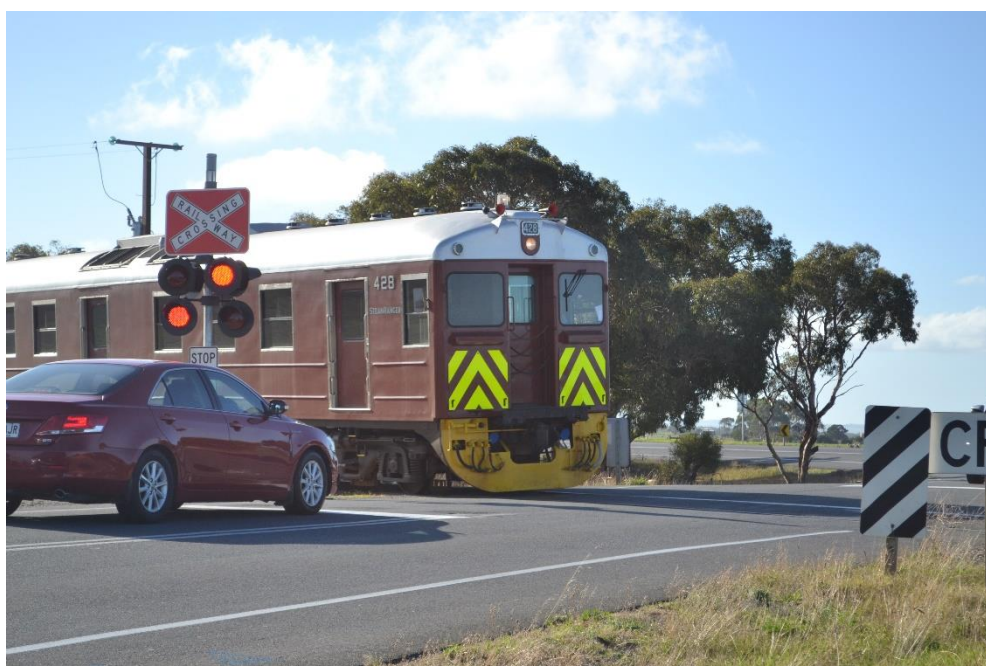
Crossing active  
warning in  
operation after  
commissioning

Funding has since been obtained to upgrade the level of crossing protection to active control by

- Installation of railway crossing flashing signal assembly's (RX-5)
- Installation of active advance warning assembly's (RX-11)
